RESEARCH MEMORANDUM

AN ANALYSIS OF LONGITUDINAL-CONTROL PROBLEMS
ENCOUNTERED IN FLIGHT AT TRANSONIC SPEEDS
WITH A JET-PROPELLED AIRPLANE

Harvey H. Brown, L. Stewart Rolls,
and Lawrence A. Clousing

Ames Aeronautical Laboratory
Moffett Field, Calif.

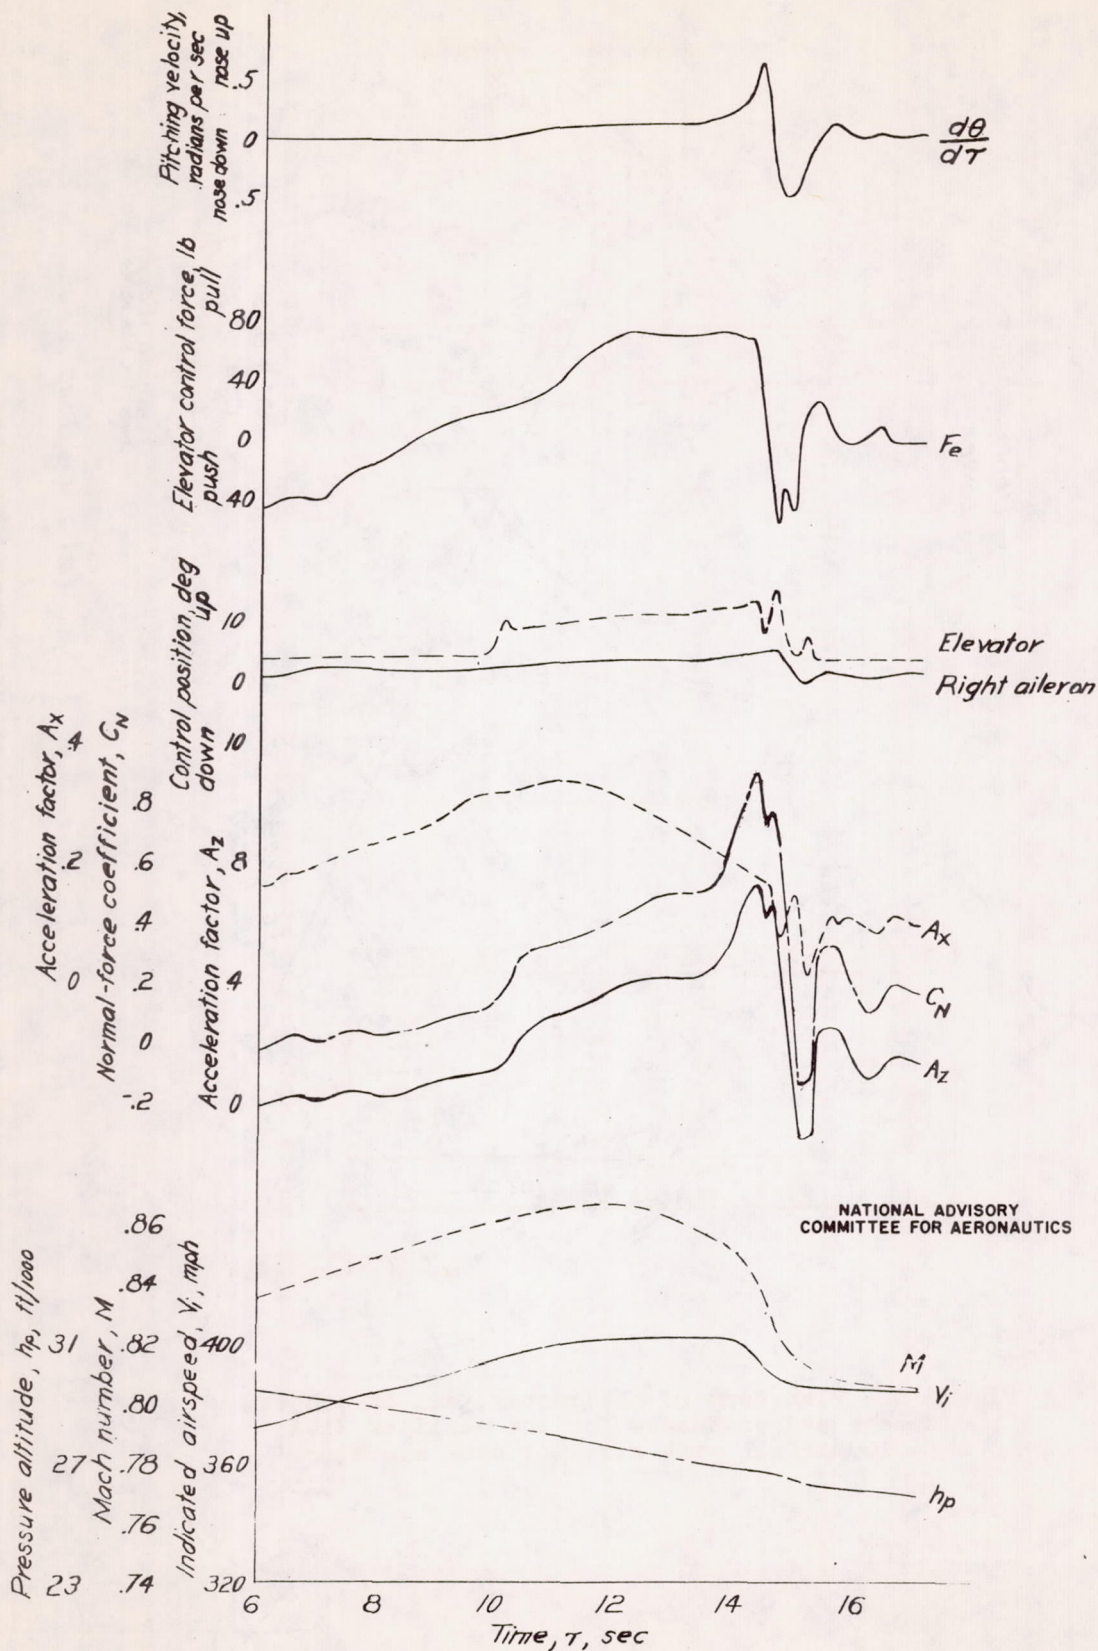
Figure 6. — Time history of dive recovery

A time history of various quantities measured during the dive recovery is shown in figure 6. From a maximum dive angle of about 40° a gradually increasing rate of recovery was carried out up to 13.3 seconds. The airplane normal-force coefficient at this time was approximately 0.49 at a Mach number of 0.858. At this point, without appreciable change in elevator angle, the airplane suddenly pitched up to $C_N = 0.89$ at $M = 0.844$ during a time interval of about 1 second. The maximum C_N occurred at about 14.25 seconds with the maximum angle of attack indicated as occurring slightly later, which suggested that a stall had been encountered and which was later verified from the pressure-distribution measurements.

The maximum Mach number, 0.866, was reached at about 11.75 seconds. As the pull-out progressed the Mach number decreased, the rate of decrease being very rapid near the end of the pull-out.

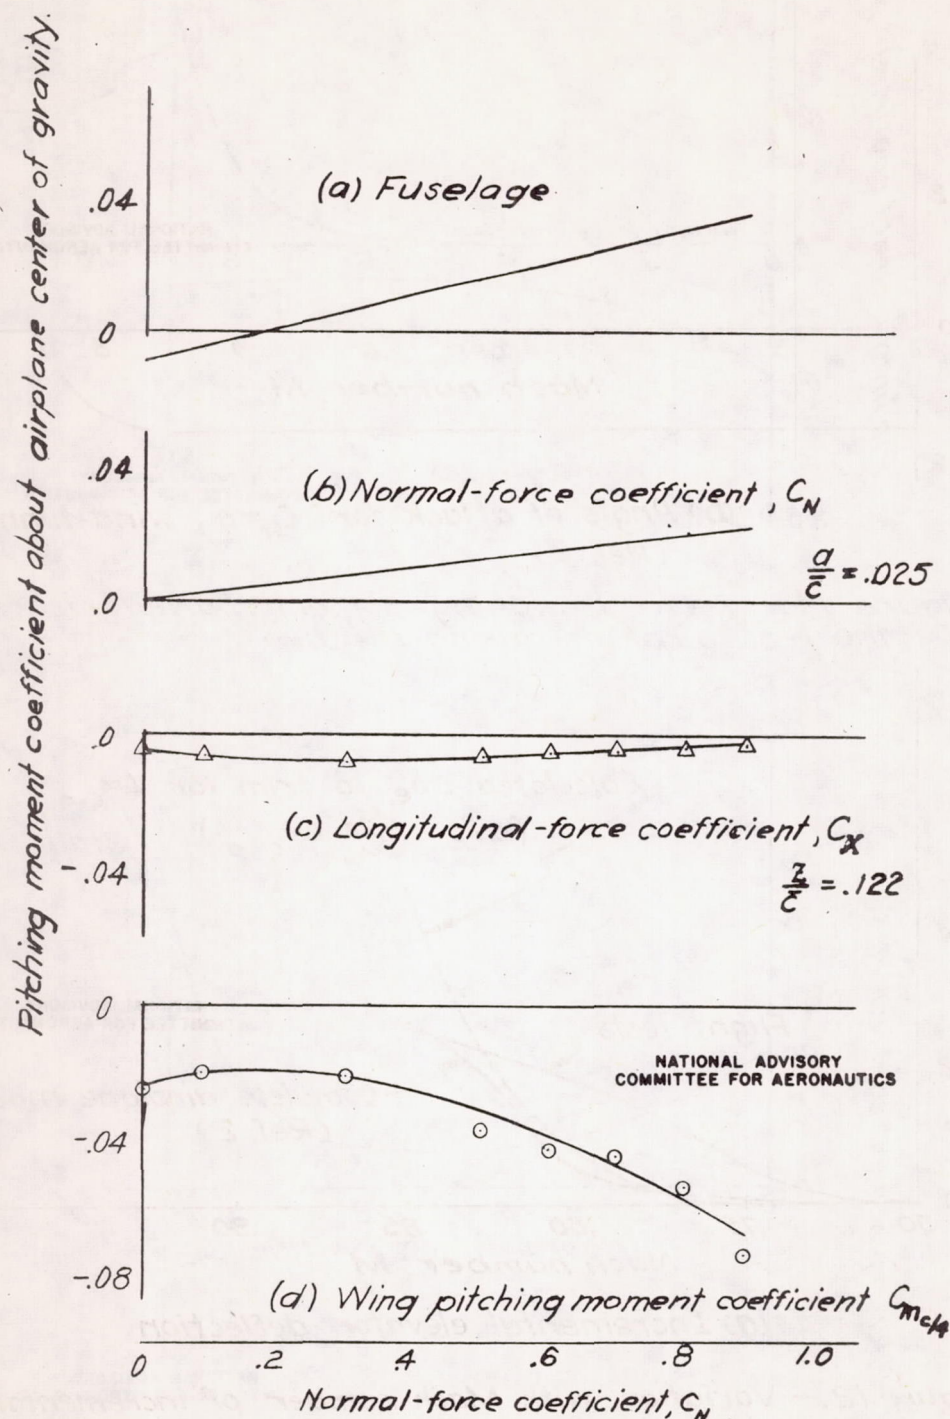
Figure 13.—Variation of the quantities affecting the airplane tail-off pitching-moment coefficient with normal-force coefficient during the dive.

Wing pitching moment.— The wing-pressure measurements made during the dive allow an exact determination of the contribution of the wing toward the balance and stability of the airplane. Figure 13(d) presents the values of $C_{m_{c/4}}$ of the wing during the dive. Since all the values of $C_{m_{c/4}}$ are negative and since $dC_{m_{c/4}}/dC_N$ is negative at the higher lift coefficients, the wing could not have directly produced the pitch-up. However the change in $dC_{m_{c/4}}/dC_N$ from a positive value at C_N below 0.2 to a

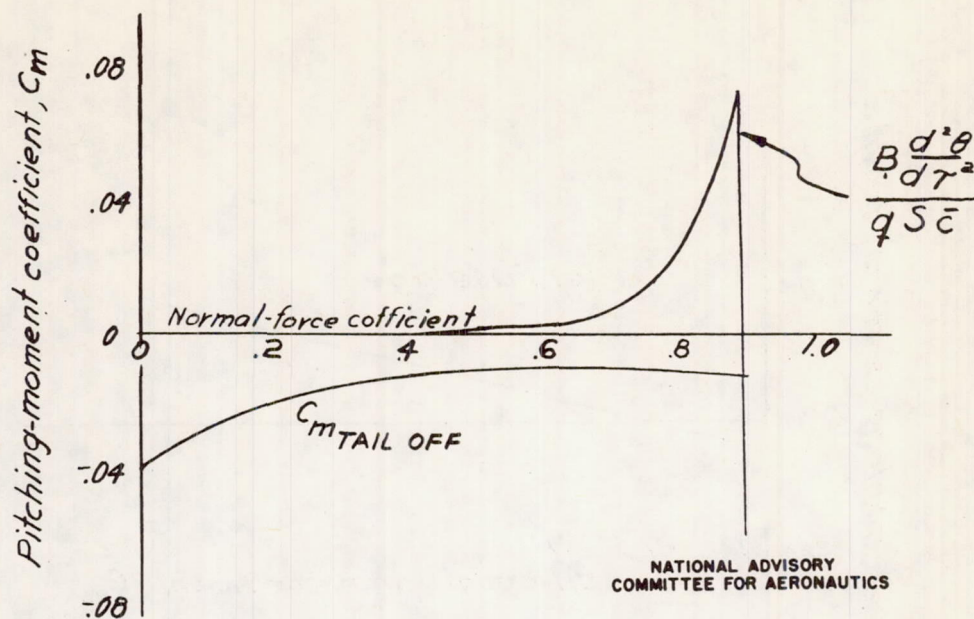
Figure 14.—Derived pitching-moment characteristics of the test airplane during the dive.

The tail-off pitching-moment coefficient is presented in figure 14. Also shown is the out-of-balance pitching-moment coefficient $B(d^2\theta/d\tau^2)/q c S$ derived from the measured slope of the pitching-velocity curve of figure 6. From these two curves the pitching-moment coefficient produced by the tail was determined according to equation (3) and is presented in figure 15. The results indicate that the tail pitching moment became increasingly positive at the higher values of C_N up to the stall. Thus by a process of elimination it has been deduced that the tail pitching moment was the principal cause of the pitch-up.

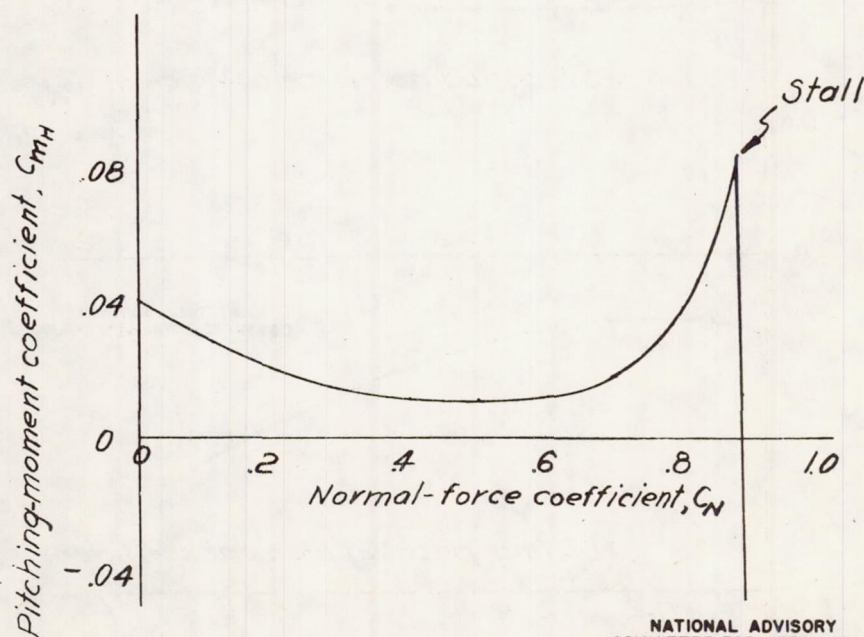
Figure 15.—Derived pitching-moment coefficient of the horizontal tail during the dive.

of these variables caused the abrupt pitch-up will now be considered. The method of analysis for α and q_H/q will be to solve for the variation that is required for each one of these variables to produce the tail pitching-moment-coefficient curve of figure 15, assuming reasonable values for the two remaining unknowns.

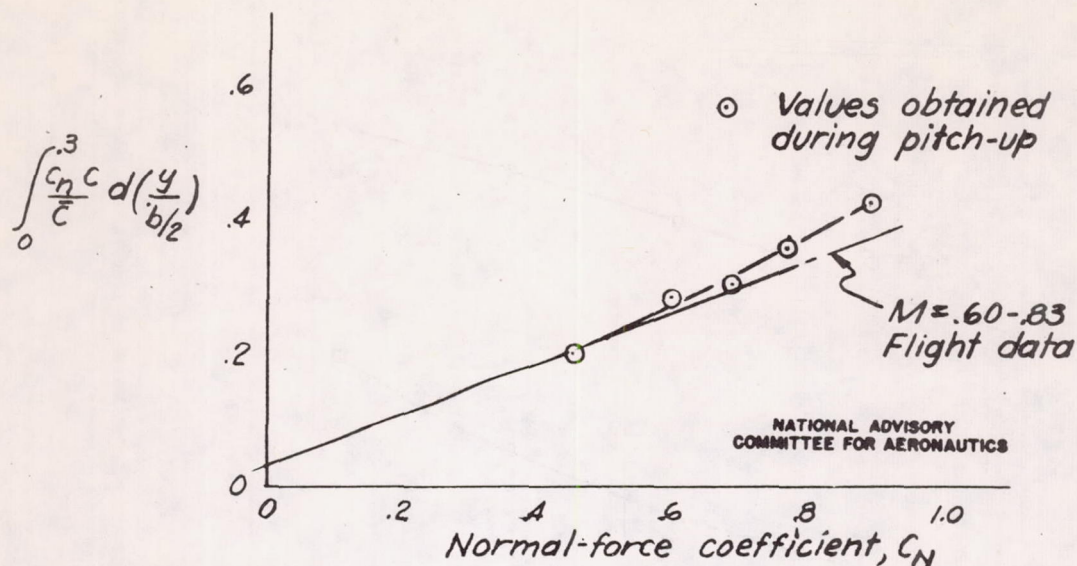
Figure 16.— Variation of wing load over center section with normal-force coefficient.

The integrated center-section loading obtained from the span-wise loadings of reference 1 is presented in figure 16. Also shown are values obtained during the dive which are slightly larger than those indicated from the low-speed results, probably due to the fact that the ailerons were deflected upward. At any rate, there is insufficient increase in downwash to produce the pitch-up.

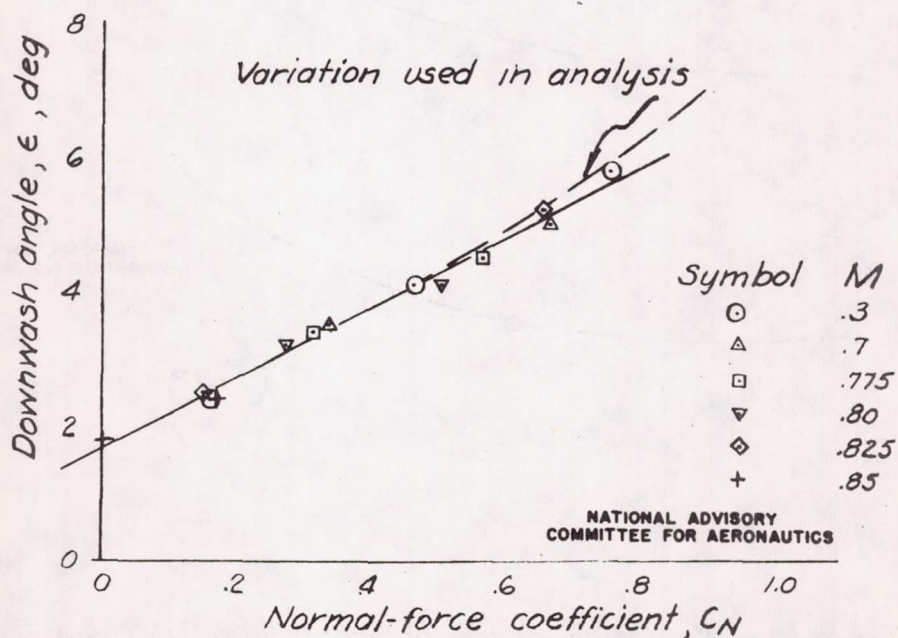
Figure 17.— Variation of downwash angle with normal-force coefficient from tests in the Ames 16 FT High-speed Wind Tunnel and corrected variation used in analysis.

From wind-tunnel tests² of a 1/3-scale model of the test airplane the derived downwash angle variation with C_N for a range of Mach numbers from 0.3 to 0.85 was obtained and is presented in figure 17. No Mach number effect is apparent. The variation of ϵ with C_N thus obtained was corrected for the increase in center-section loading and the corrected variation as used in the subsequent analysis is also shown in figure 17.

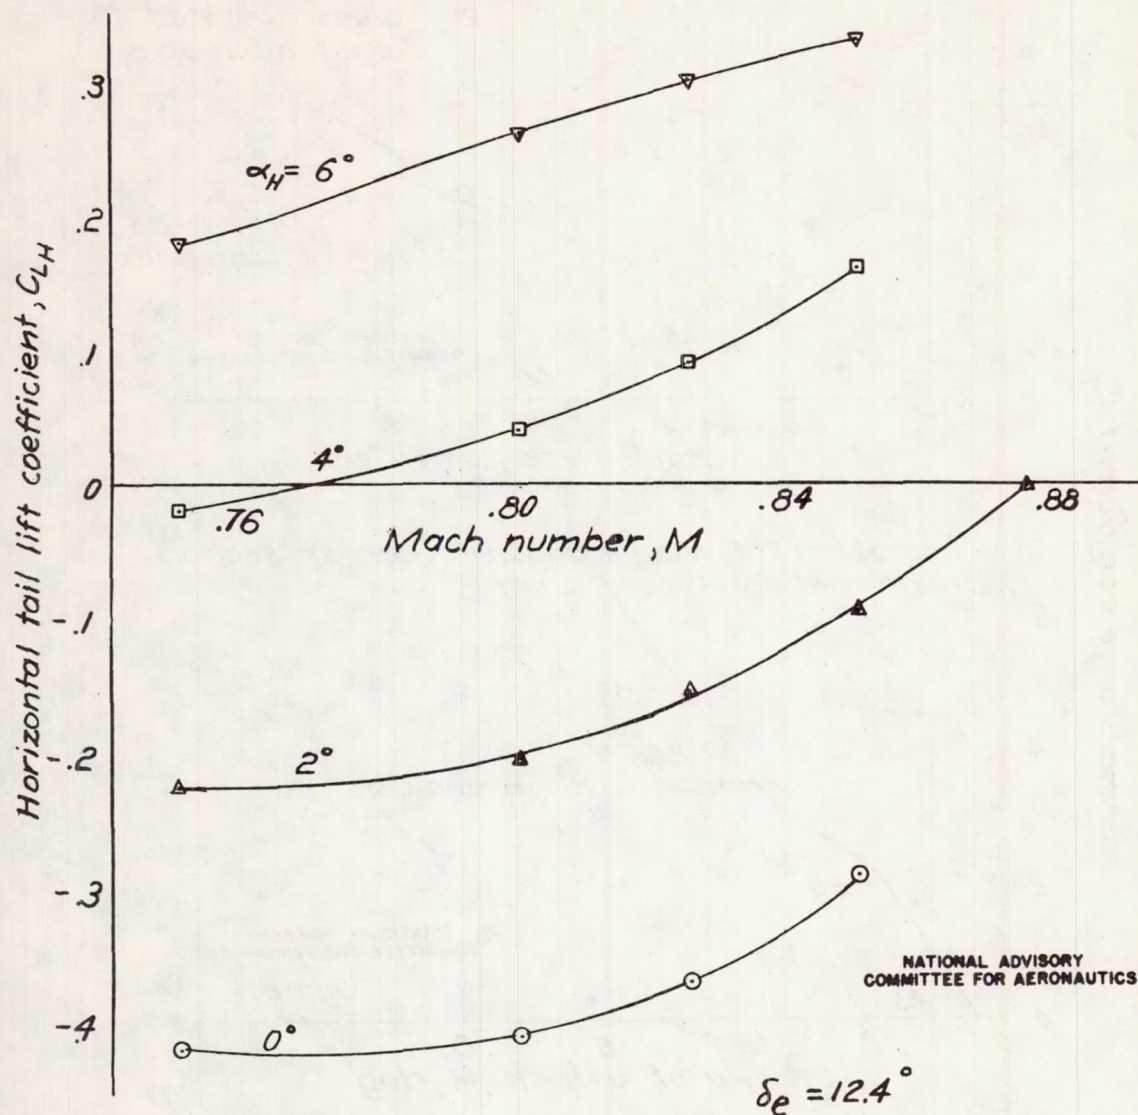
Figure 18.— Variation of the horizontal-tail lift coefficient with Mach number for constant values of tail angle of attack.

for the values of δ_e corresponding to specific points during the dive. A typical example is shown in figure 18.

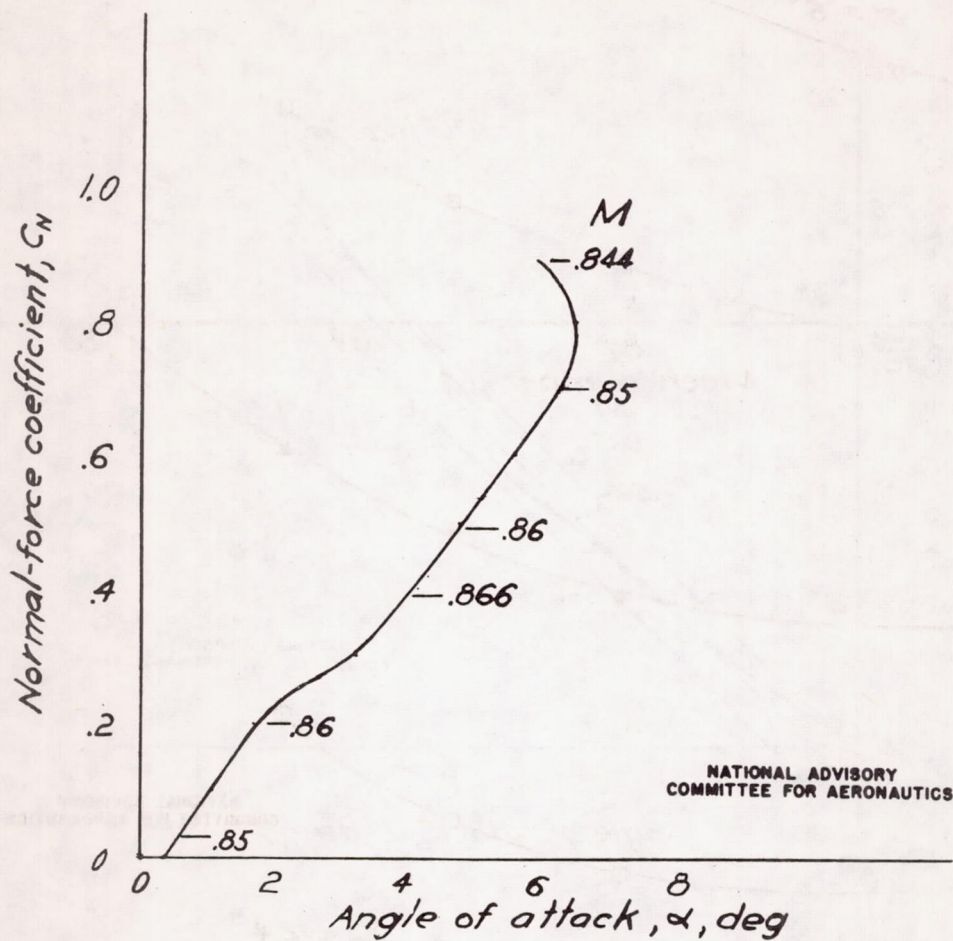
Figure 19.—Derived variation of normal-force coefficient with angle of attack required to produce the dive recovery.

which (in light of the assumptions made) allows the values of α to be determined. The variation of α with C_N thus derived is shown in figure 19. This variation is required to produce the longitudinal characteristics of the dive. Comparison of this lift curve with that derived from extrapolation of the wind-tunnel tests of reference 2 (fig. 20) indicates dissimilarities. For the portion of the dive before the pitch-up, the difference in slopes tends to eliminate the lift curve as the cause of the increased stability. In regard to the pitch-up, the results shown in figure 20 indicate that the effect of decreasing the Mach number as C_N is increasing from 0.5 to 0.89 is to markedly increase the slope of the curve. This would agree with the steep slope in figure 19 between $C_N = 0.5$ and 0.7. For C_N greater than 0.7, however, the reduction in α with increasing C_N is improbable. Therefore, it may be concluded that the variation of α with C_N may explain part of the reduction in stability during the pitch-up due to the fact that the airplane Mach number was decreasing, but it does not entirely explain the latter portion of the pitch-up above 0.7 C_N .

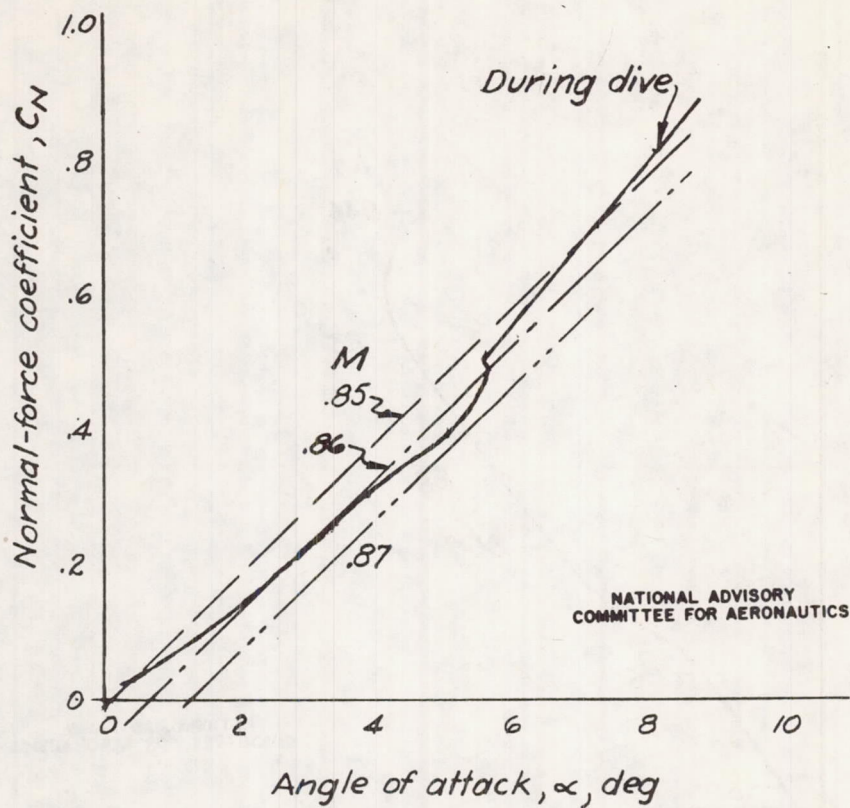
Figure 20.— Assumed variation of normal-force coefficient with angle of attack.

1. Variation of ϵ with C_N is as shown in figure 17.
2. Variation of α with C_N is as shown in figure 20. This variation was derived from an extrapolation of the wind-tunnel results of reference 2.
3. Tail characteristics are as determined from wind-tunnel tests of the isolated tail.

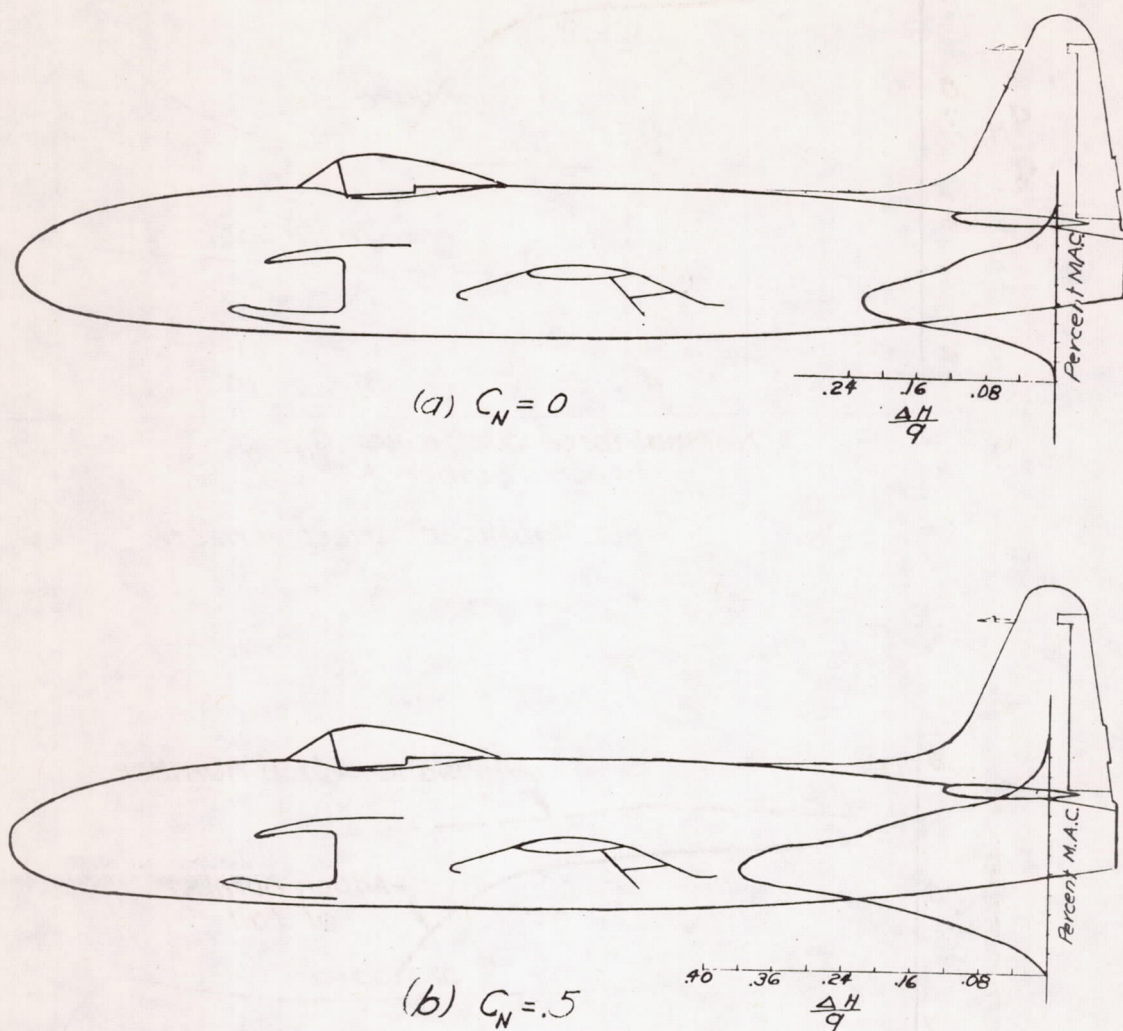
Figure 22.— Variation of dynamic pressure ratio and Mach number at the tail required to produce the dive recovery.

These assumptions coupled with measured values allow α_H to be determined, leaving only q_H/q , $\partial C_{LH}/\partial \alpha_H$, and $\partial C_{LH}/\partial \delta_e$ as unknowns in equation (4). Since all these were shown to be a function of the total-head loss over the tail, the required variation of q_H/q was found by a series of successive approximations. The variation of q_H/q and Mach number at the tail required to explain the abrupt pitch-up is presented in figure 22. From this it may be seen that the required reduction in dynamic pressure increases with increase in C_N . This is quite plausible, since at higher angles of attack the wake becomes broader and the tail moves toward the wake.

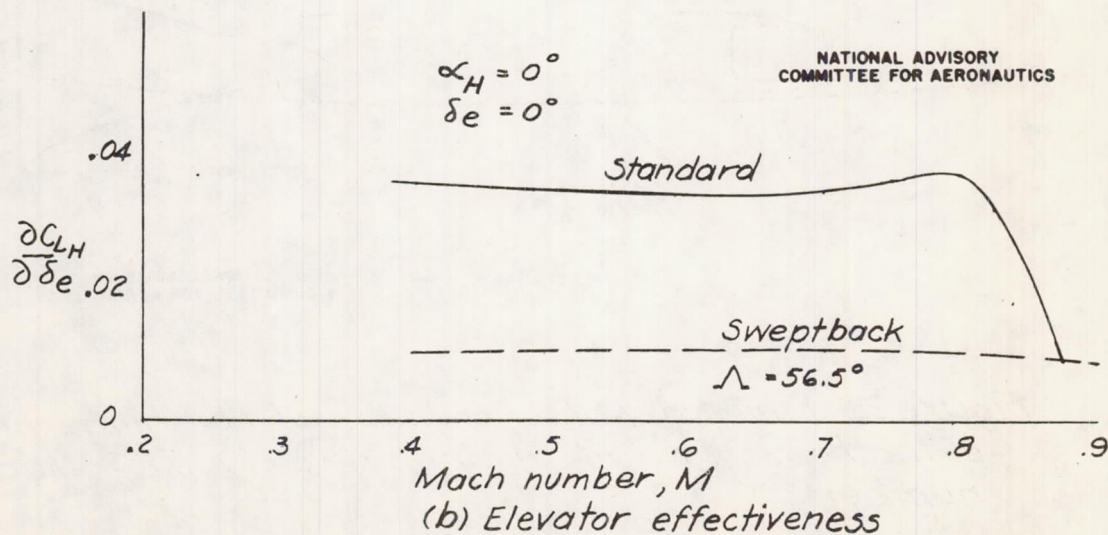
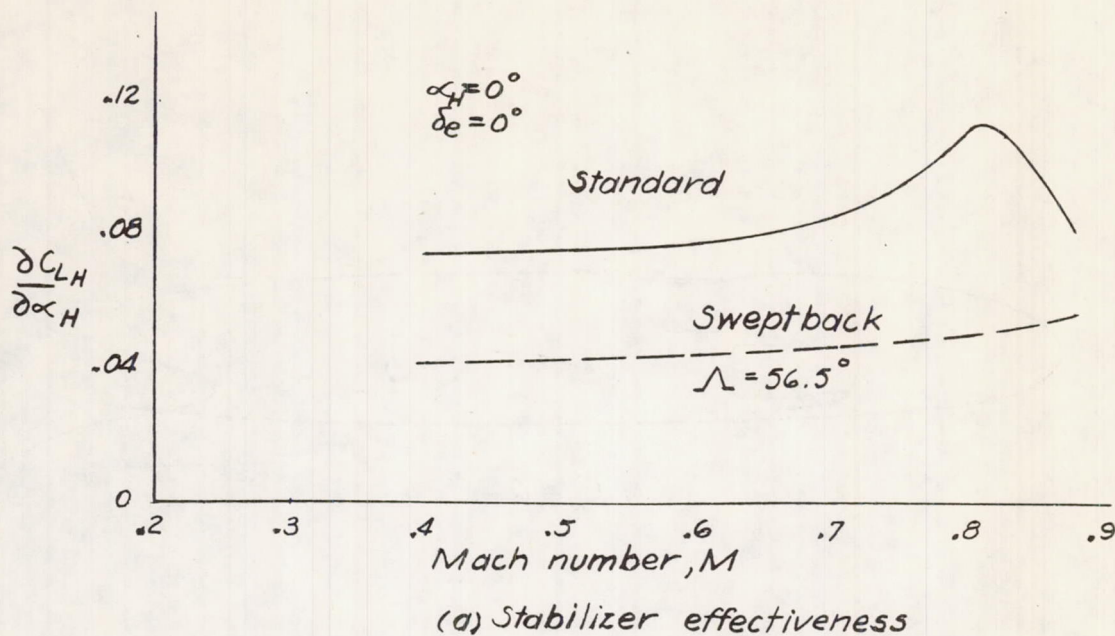
Figure 24. — Horizontal-tail characteristics from tests of a $\frac{1}{3}$ -scale model in Ames 16 Ft. High-speed Wind Tunnel.

The longitudinal problems thus appear to rise from the effect of Mach number on the angle of attack for zero lift and elevator and stabilizer effectiveness. The use of a symmetrical wing would reduce the shift with Mach number in the angle of attack required for a given lift coefficient at least for moderate lift coefficients. This would reduce the increment in elevator angle needed for balance and thereby proportionately reduce the effect of a change in elevator effectiveness on balance. A partial solution would be to alleviate the effects of Mach number on elevator effectiveness and stabilizer effectiveness. The use of a swept-back tail surface would accomplish this purpose as may be observed in figure 24 which compares the

elevator effectiveness and stabilizer effectiveness at high Mach numbers for the standard tail and for the tail swept back.
